EXISTING CONDITIONS EVALUATION

**PANELYTE SITE
2403 SOUTH BURDICK STREET
CITY OF KALAMAZOO
KALAMAZOO COUNTY, MICHIGAN**

CITY OF KALAMAZOO

April 2016
Project No. 825830

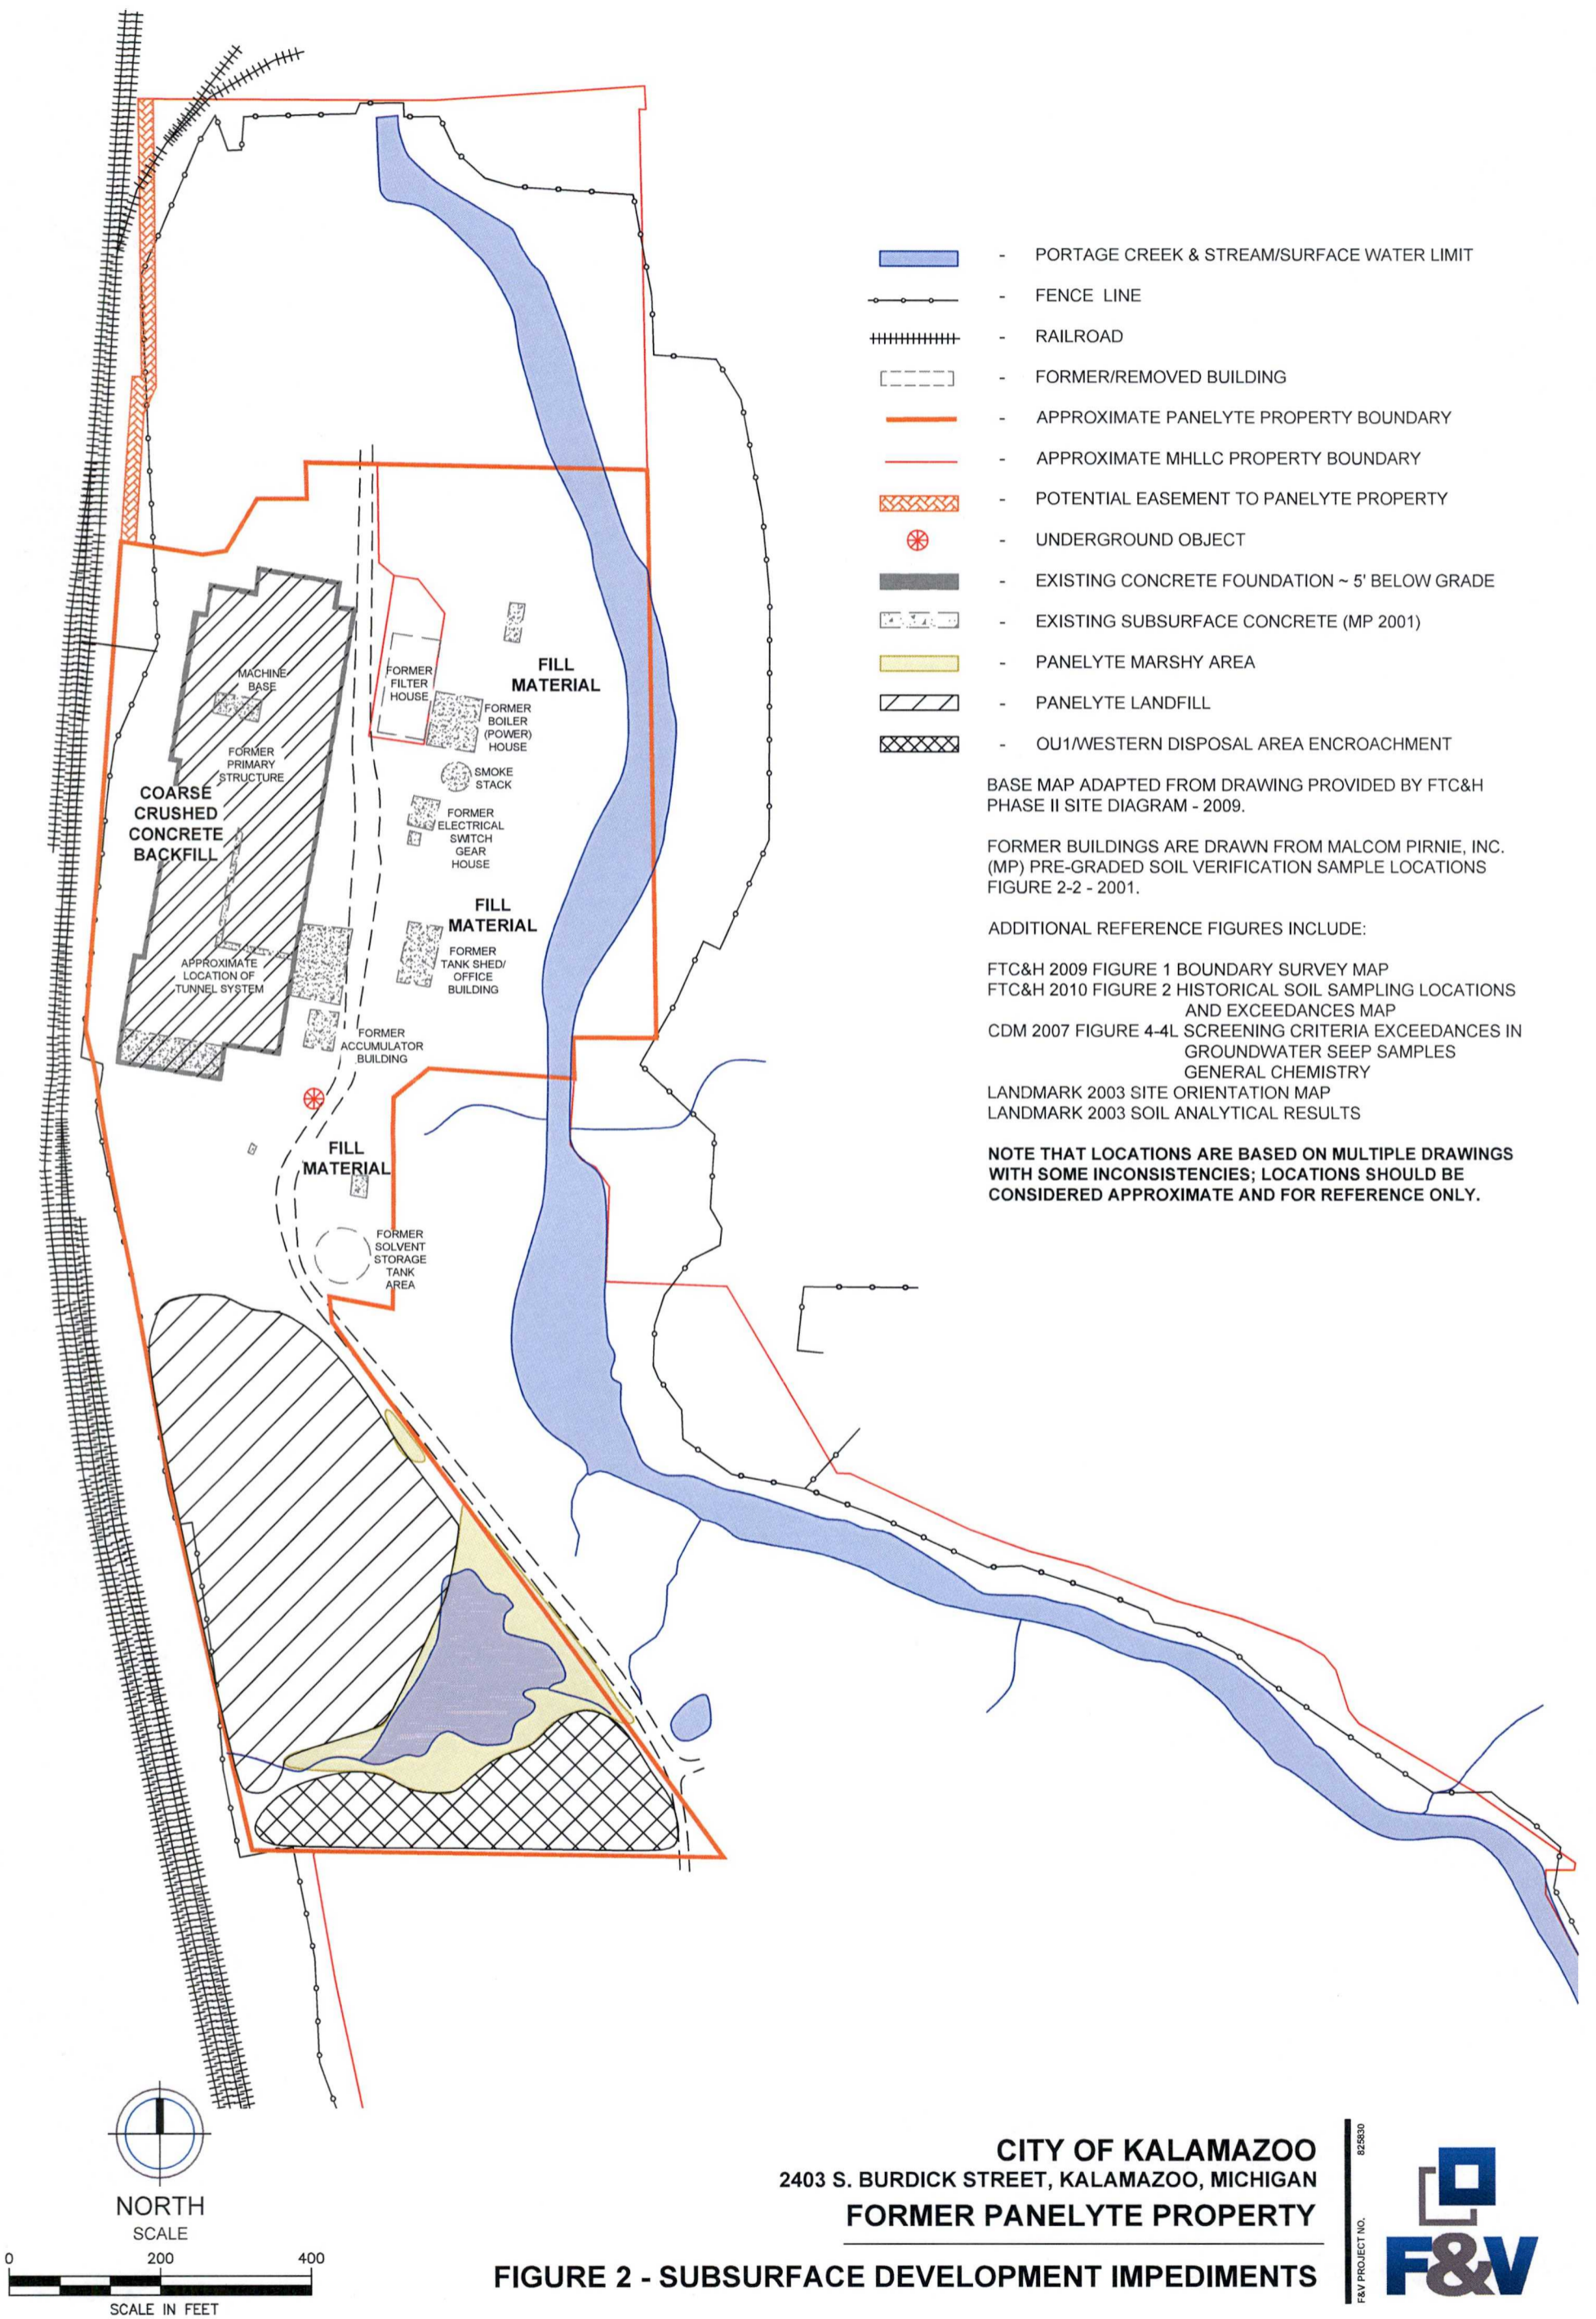
This portion of the Site was the former location of the Site buildings and improvements and is the area that has the most potential to be redeveloped in the future. The majority of the Site buildings and improvements have been demolished. The concrete slab of the main building was contaminated with PCBs and was removed and disposed offsite. A few remnant improvements such as: underground vaults, rail lines, and fencing remain. Portions of the concrete building foundations were crushed onsite during demolition activities and used to backfill the building excavations with the additional crushed materials spread over portions of the Site. Portions of the visible crushed concrete materials on the Site surface are very coarse (3 – 4-inches). Not all building foundations and concrete slabs were removed, the main building foundation was reported to be very massive and was removed to approximately 5-feet below grade. It was reported that several of the smaller building concrete slabs were cracked and left in place. It is likely that the building foundations of these building remain also. The locations of the buried building foundations and slabs are shown on Figure 2.

Portions of this area of the Site appear to have been historically low-lying and were filled to allow development, likely during the paper-making operations at the Site. Based on the boring logs from the different environmental investigations the backfill included waste materials such as coal ash/slag, brick, rubble, etc.. The complete nature and extent of the fill materials has not been documented. Over 10-feet of fill materials was reported in some of the boring logs. The fill materials blend with the Panelyte Dump materials to the south. The estimated location of the fill materials are shown on Figure 2.

An "Unidentified Object" was reported as being located to the southeast of the former main building (shown on Figure 2). This object was reported to be a pipe or possibly an underground storage tank. It is not known if any further investigations were conducted to determine what the object was and if it is still present at the Site.

Waste materials from the adjacent Allied Paper Site – Western Disposal Area are located on the southern portion of the Panelyte Property – shown as the “OU-1 Encroachment Area” on Figure 2. The general dividing line between the Western Disposal Area wastes and the Panelyte Dump wastes is the Panelyte Marsh. It is likely that Western Disposal Area and Panelyte Dump Wastes are co-mingled beneath the Panelyte Marsh.

Buried Building Foundations and Slabs - There are numerous buried building foundations and cracked concrete slabs that are reported to be buried at the Site. The presence of these subsurface impediments may limit the types of structures that can be developed on the Site in the future.

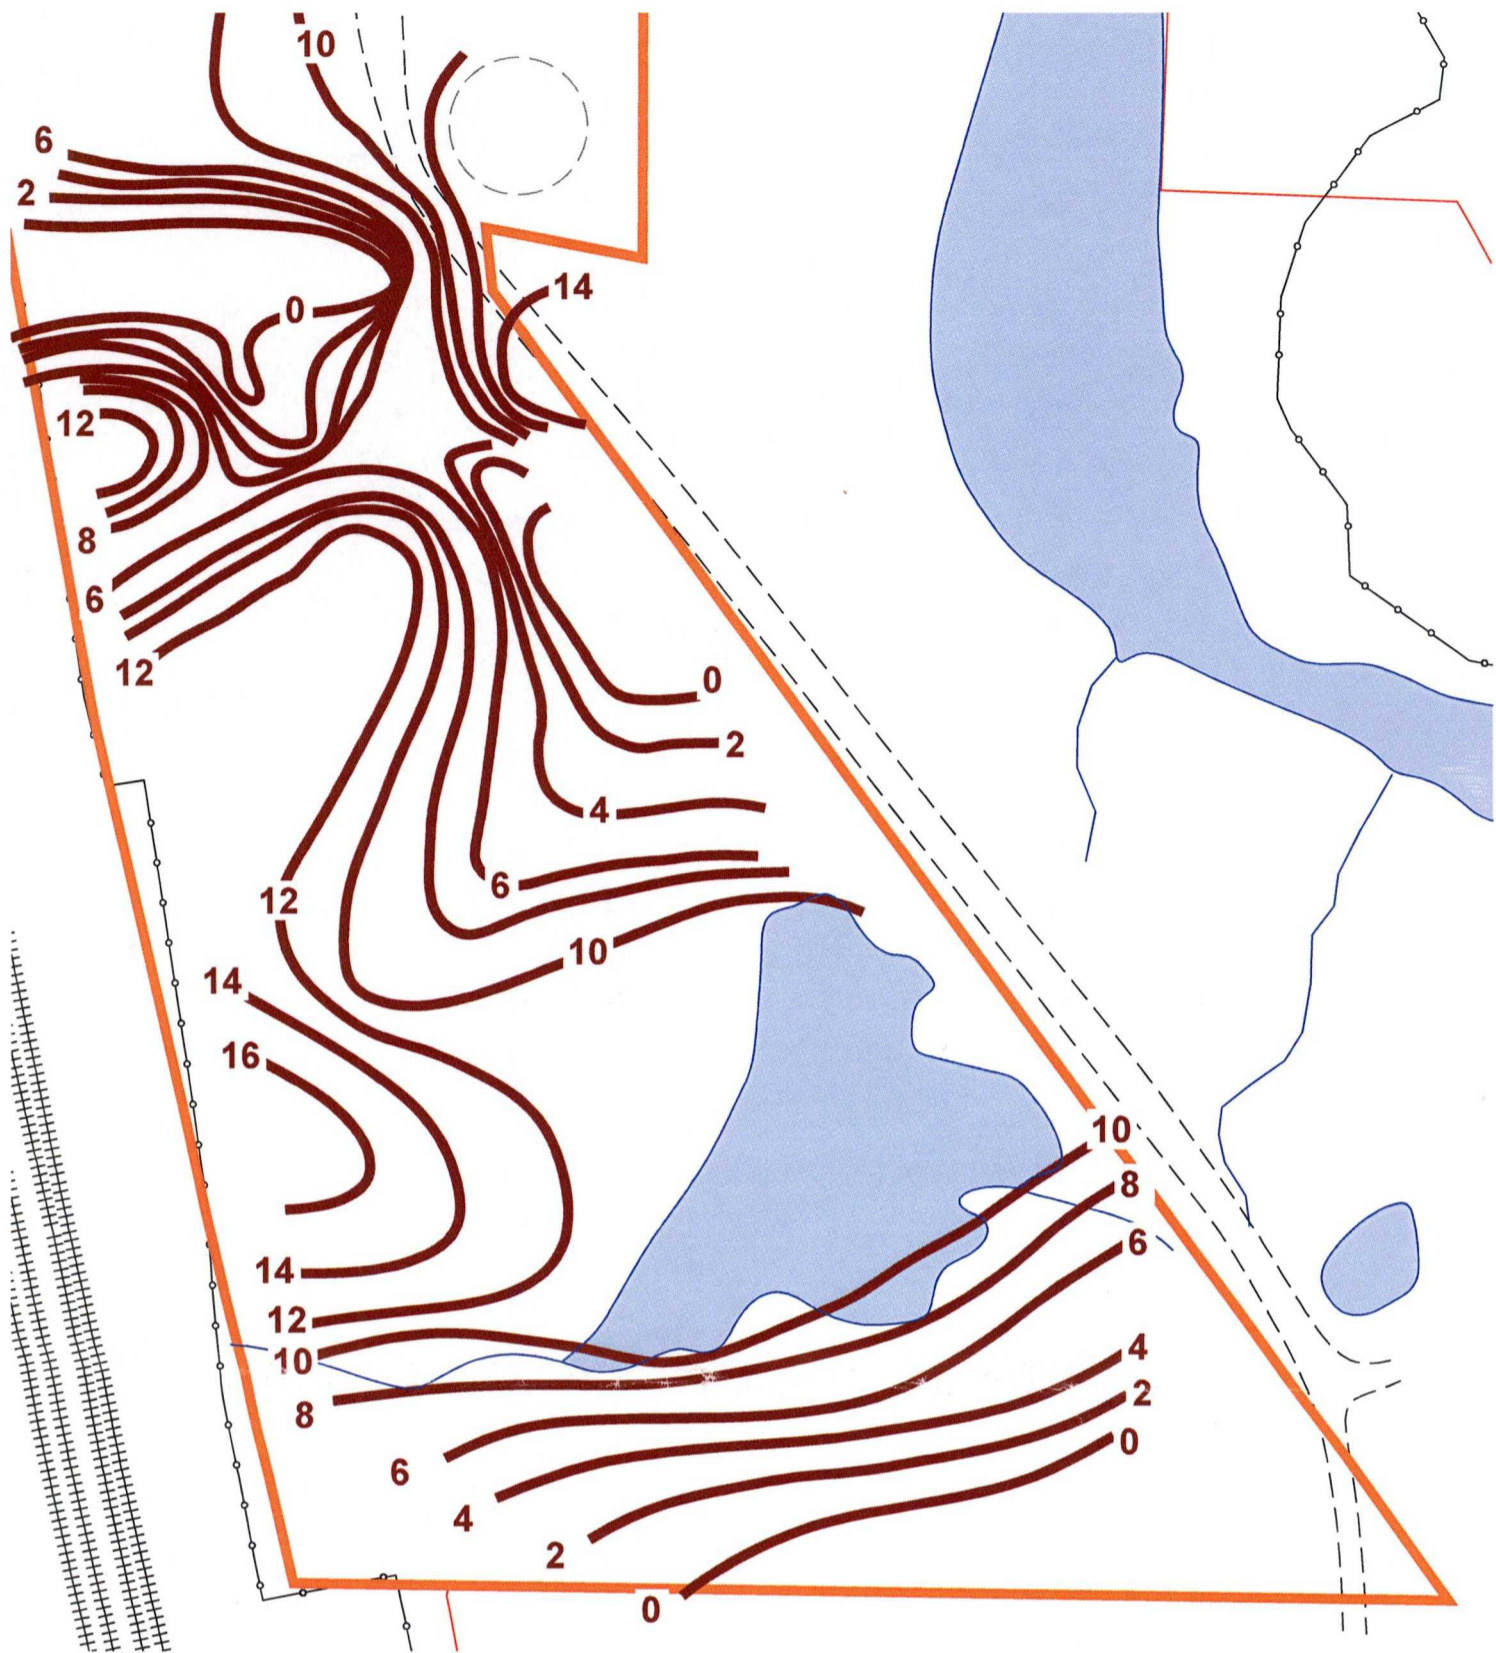
FIGURE 3: PANELYTE DUMP THICKNESS ISOPACH

Numerous borings were installed in the Panelyte Dump Area during the 2004 Landmark investigation to assess the extent of waste materials and the conditions of soil and groundwater. The Landmark investigation data indicates that up to 16-feet of waste material/fill is present in the Panelyte Dump. The estimated extent and thickness of the Panelyte Dump is shown on Figure 3. The Panelyte Marsh is present at the southern end of the Panelyte Dump area. It is likely that waste materials are present beneath all, or portions of the Panelyte Marsh.

Panelyte Dump Remediation – In order to remove ongoing sources of contamination to soil, groundwater and surface water at the Site and remove Due Care liabilities, the Panelyte Dump may need to be remediated. The dump area is approximately 4 acres in size. If we assume an average waste thickness of 8-feet and that the wastes are non-hazardous, that would equate to approximately 40,000-cubic yards of material that would need to be excavated and disposed offsite in a Type II Landfill. At a budget cost of \$45/cubic yard, we estimate a cost of \$1,800,000. A potential cost savings could be realized by removing the wastes in the Panelyte Dump and incorporating them in the OU1 Remedy.

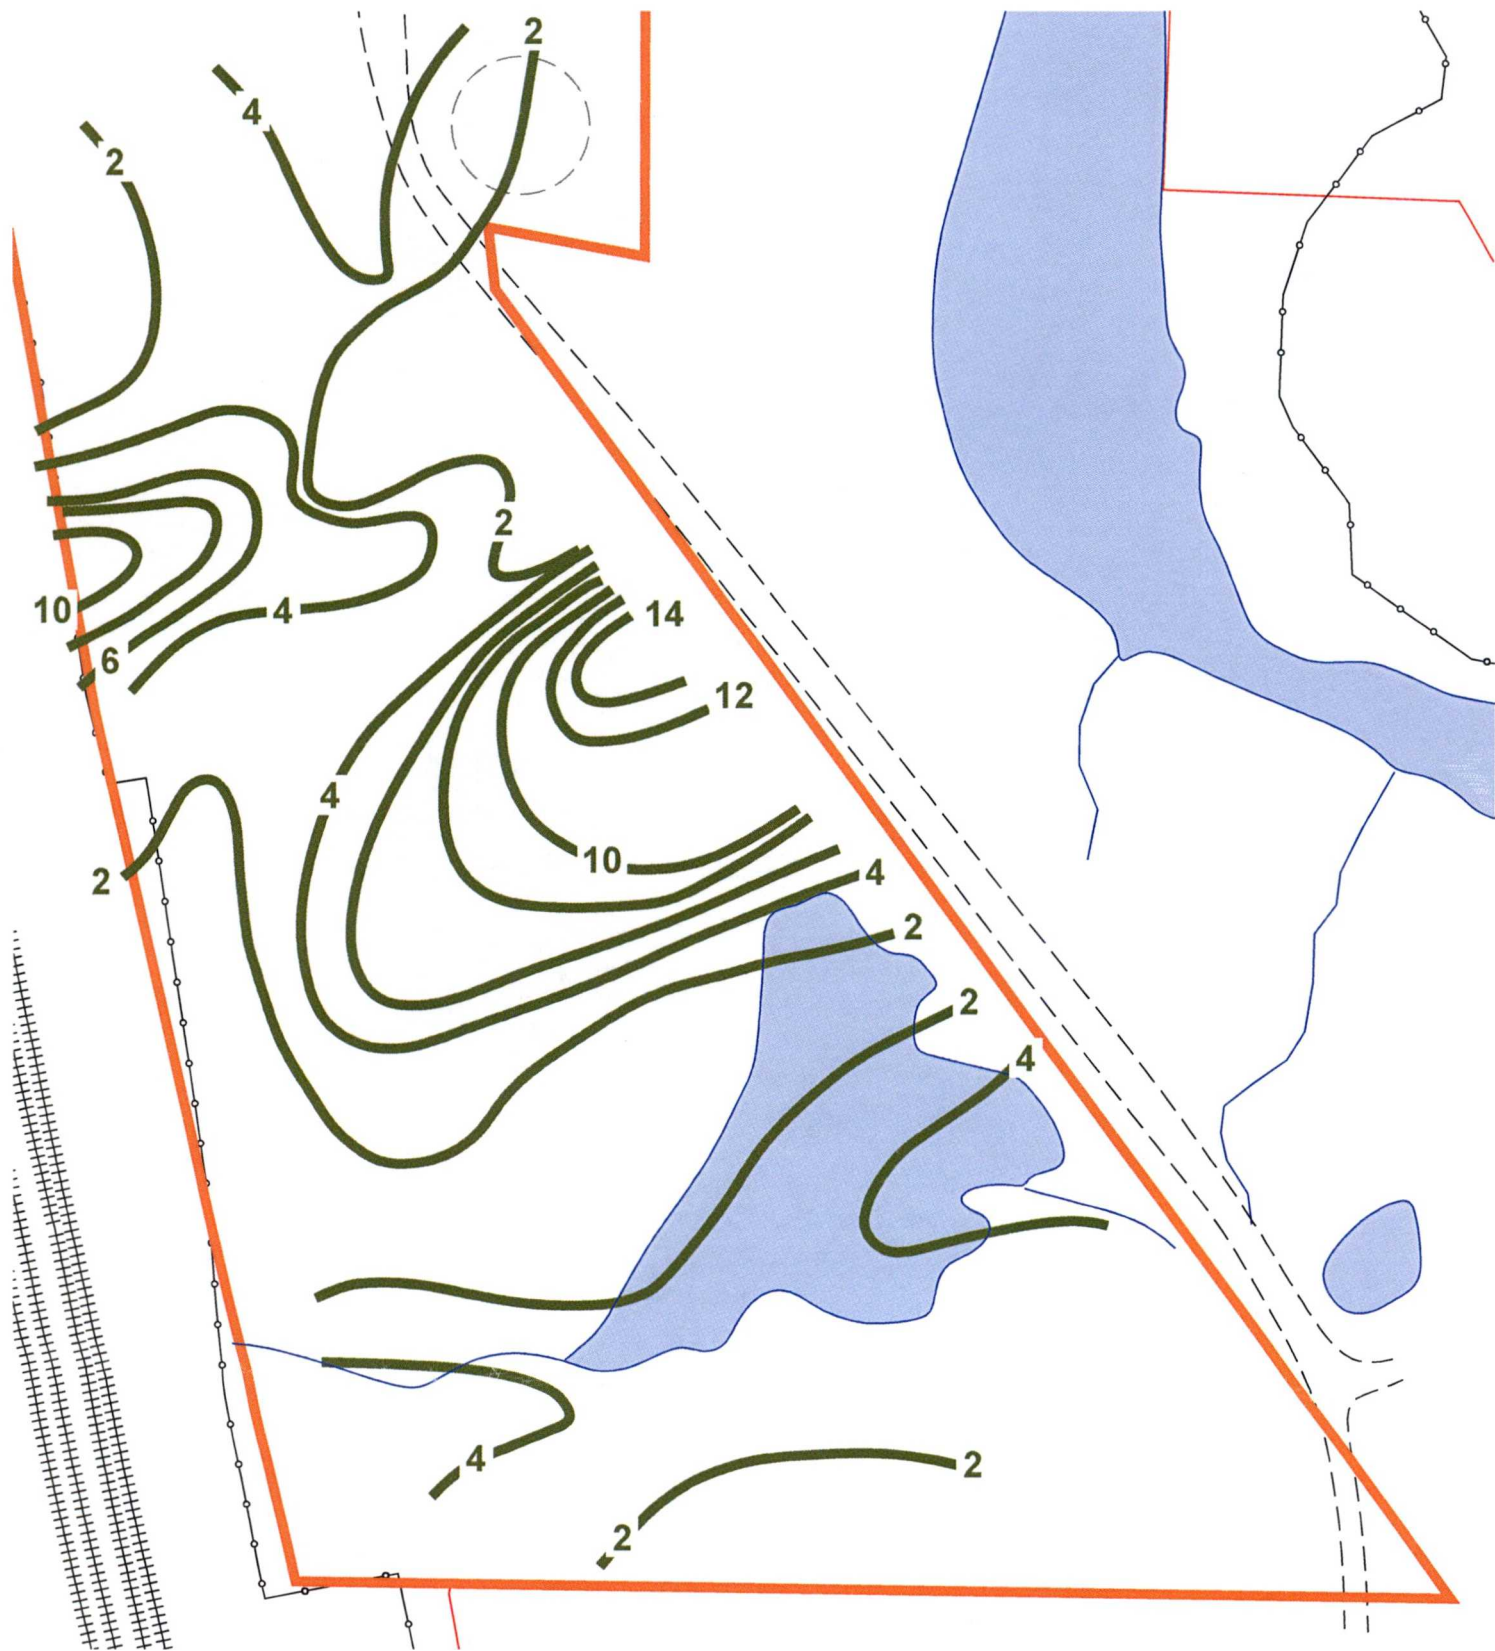
CITY OF KALAMAZOO
2403 S. BURDICK STREET, KALAMAZOO, MICHIGAN
FORMER PANELYTE PROPERTY
FIGURE 4: PEAT THICKNESS ISOPACH

The boring logs for Site investigations also indicate that a peat/marl unit underlies portions of the waste and fill materials at the Site. The peat/marl unit likely represents the historical surface of the low-lying area before filling and dumping activities were conducted. The estimated extent and thickness of the peat/marl unit is shown on Figure 4.
